# APEX HOME INSPECTIONS

## DATE

10/20/2015

## SUMMARY

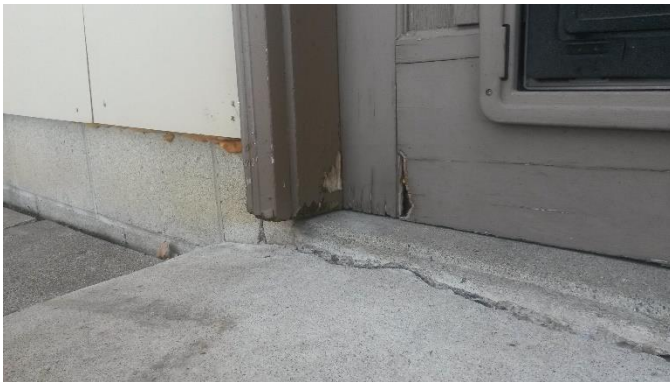
**Location:** Garage Service Door

Garage Service Door - **Defective**

Lower left jamb (looking from the outside) is rotten, as well as the lower left portion of the door. The door also drags across the garage floor slab when opened.

Condition S M **D** H NV NA **N**

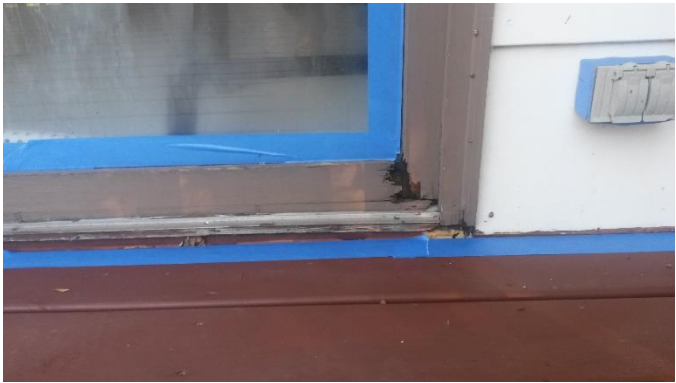
**Location:** Patio Door

Patio Door – **Defective**

Stationary panel rotten wood style lower corner.

Condition S M **D** H NV NA **N**

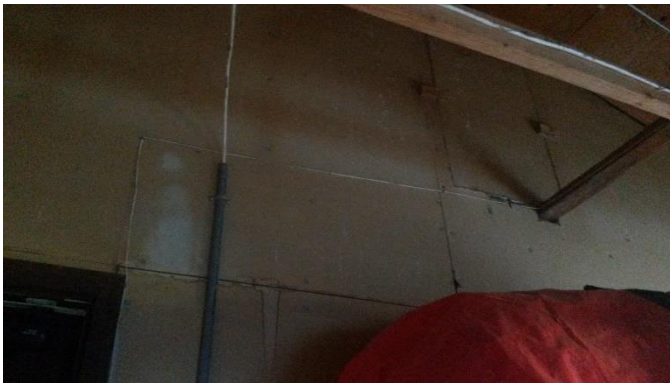
#### 27. FIREWALL

**Marginal**

The firewall joints are tight but are not taped and penetrations are not sealed

Condition S **M** D H NV NA **N**

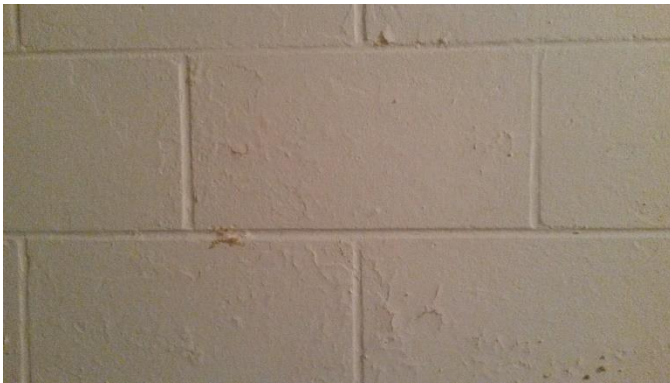
### 41. WALLS & CEILING

Exterior Basement Walls - **Marginal**

Paint is peeling and begging to show signs of water intrusion on South Wall.

Condition S **M** D H NV NA **N**

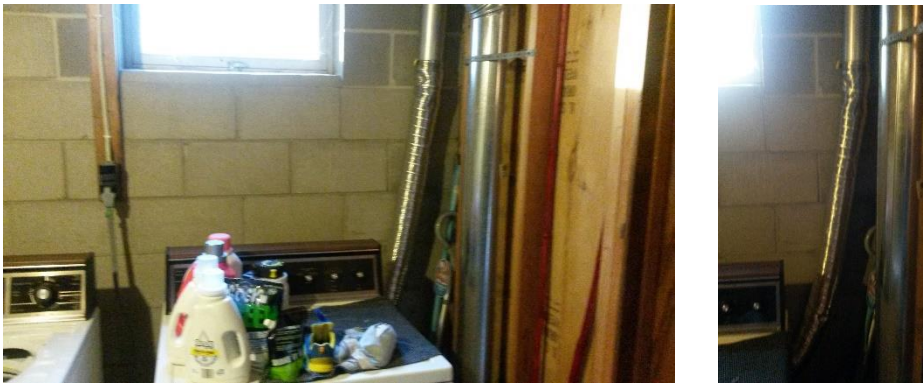
**Dryer Venting Condition** S **M** D H NV NA **N**

Dryer Venting - **Marginal**

Flexible ducting should be changed to metal ducting.

Flexible ducting should be changed to solid metal ducting.
